Existing condition of the superstructure (bearings)

Ranges from poor to fair

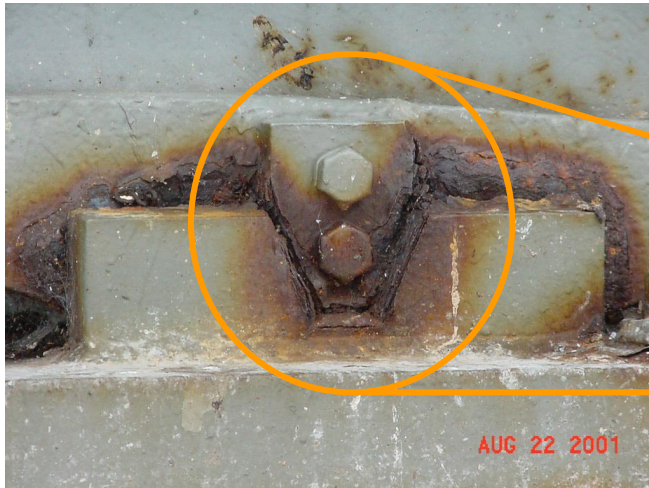
These pictures show how rust affects the bridge bearings on the superstructure. This close-up (upper left) of the moveable bearing's keeper bar shows that it has rusted in place and can no longer move. The stresses this causes have resulted in the moveable bearing shifting out of alignment (upper right) and the nut on the fixed bearing (lower left) to "explode".

Fifty (50) percent of the Claude Allouez Bridge's bearings are in this condition.
